SUMMARY OF DAMAGE CASES FROM THE DISPOSAL OF MINING WASTES

VOLUME II

APPENDICES E-L

SCS ENGINEERS 11260 Roger Bacon Drive Reston, Virginia 22090 (703) 471-6150

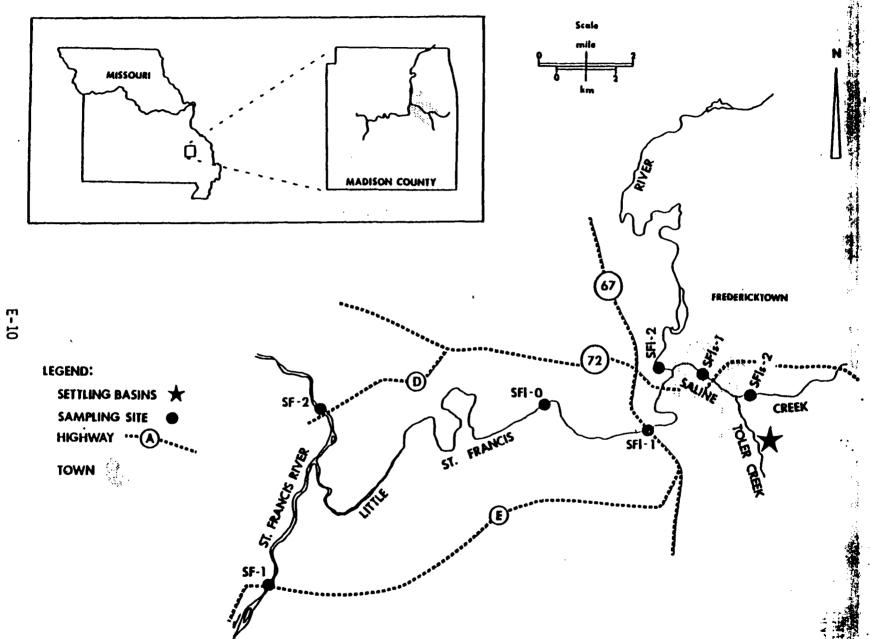
Figure 1. Sampling stations on Saline Creek and the Little St. Francis River, Madison County, Missouri, 1977-78.
